INDOOR AIR QUALITY ASSESSMENT

**Medford High School
489 Winthrop Street
Medford, Massachusetts**

Prepared by:
Massachusetts Department of Public Health
Bureau of Environmental Health Assessment
September, 2001

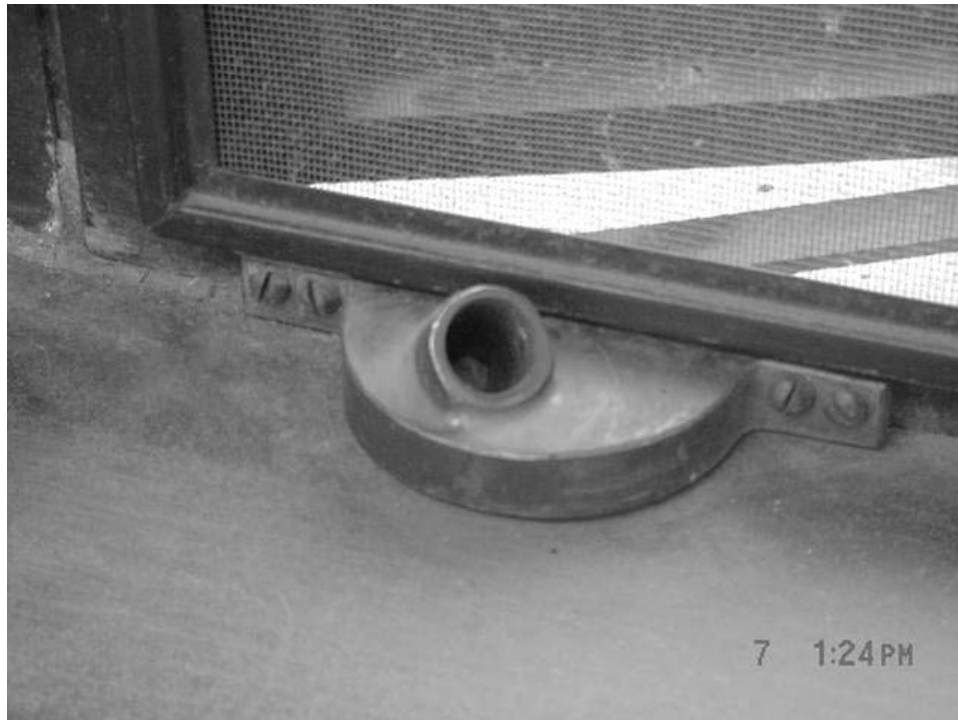
Picture 1

The school is a three-story building constructed in 1970 and is made up of a number of wings housing grades 9-12. The school also contains an early childhood center for pre-school children. A-wing is two stories and contains music rooms, art rooms and the auditorium. Science and business classrooms, as well as administrative offices, are located in B-wing. The C-wing is made up of general classrooms and a cafeteria on each of the three floors. A vocational/technical center contains various shop areas and a sports facility in the rear of the building, which includes a pool area. Windows throughout the building are openable, however school staff reported that they are difficult to open in a number of areas (e.g. damaged equipment, missing cranks) (see Picture 1).

Missing Crank on Classroom Window

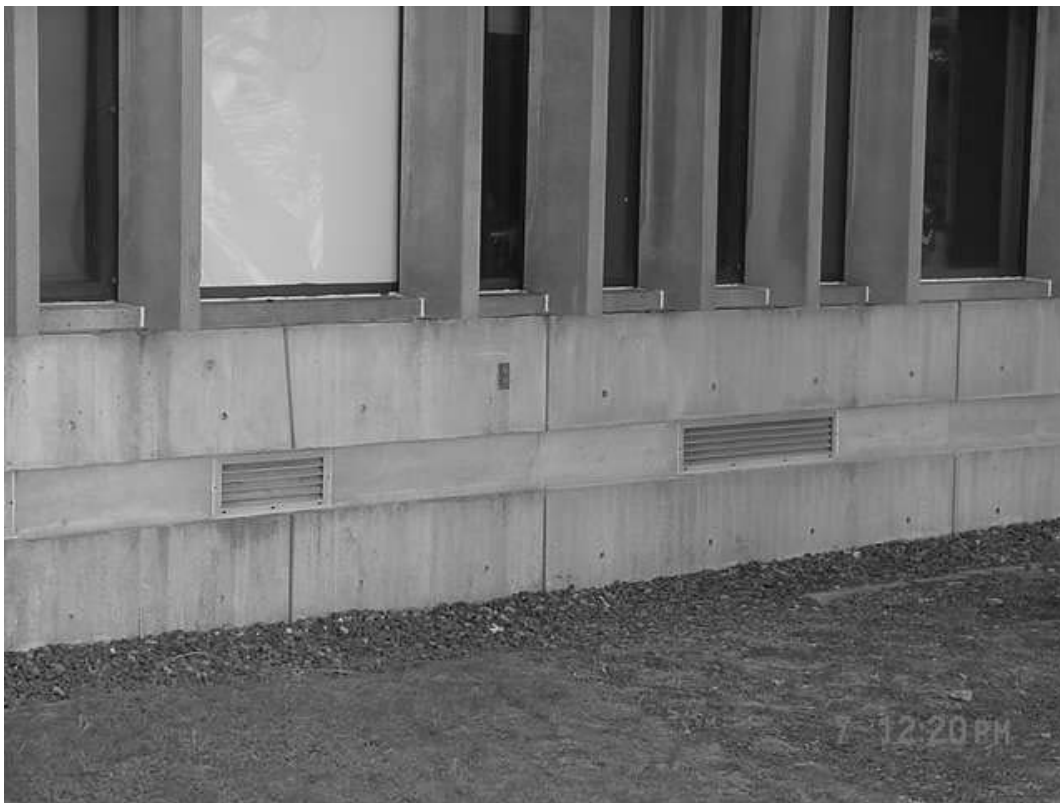
Picture 2

Fresh air in classrooms is supplied by a unit ventilator (univent) system. Univents in exterior classrooms draw air from outdoors through a fresh air intake located on the exterior walls of the building (see Picture 2) and return air through an air intake located at the base of each unit (see Figure 1). Interior rooms contain ceiling-mounted univents that are ducted to fresh air intakes on the roof (see Pictures 3 & 4). Several of these were damaged; the air intake in Picture 4 was being supported by a bucket (see Picture 5). Fresh air and return air are mixed, filtered, heated and provided to classrooms through a fresh air diffuser located in the top of the unit. Obstructions to airflow, such as papers and books stored on univents and bookcases, carts and desks in front of univent returns were seen in a number of classrooms. In order for univents to provide fresh air as designed, intakes must remain free of obstructions. Importantly, these units must remain “on” and allowed to operate while these rooms are occupied.

Univent Fresh Air Intake (Right) Unit Exhaust Vent (Left)

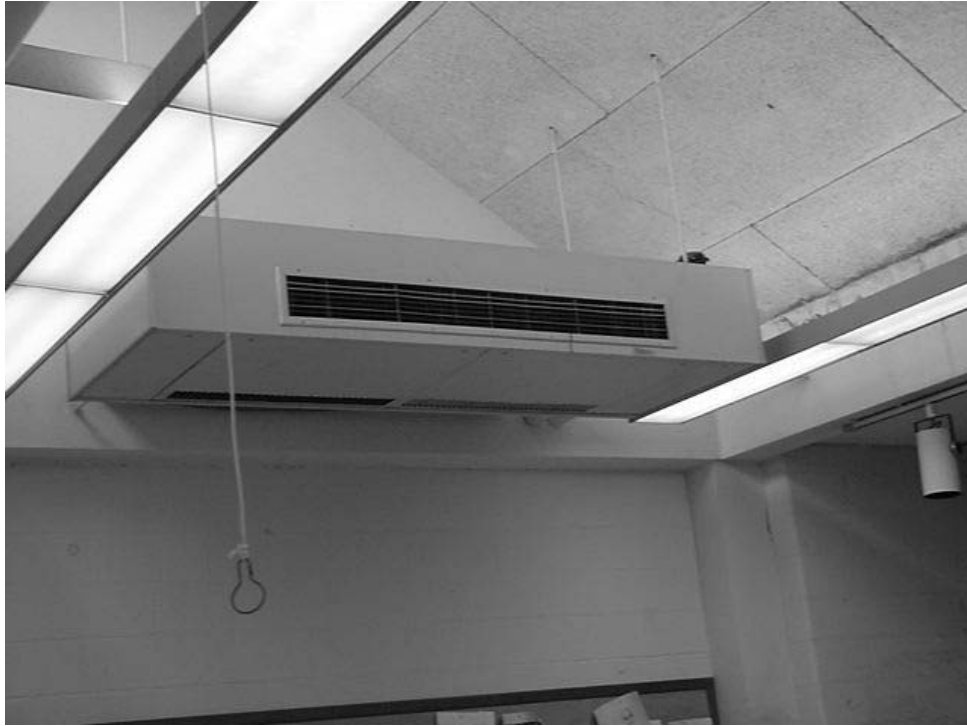
Picture 3

Ceiling Mounted Univent in Interior Classroom

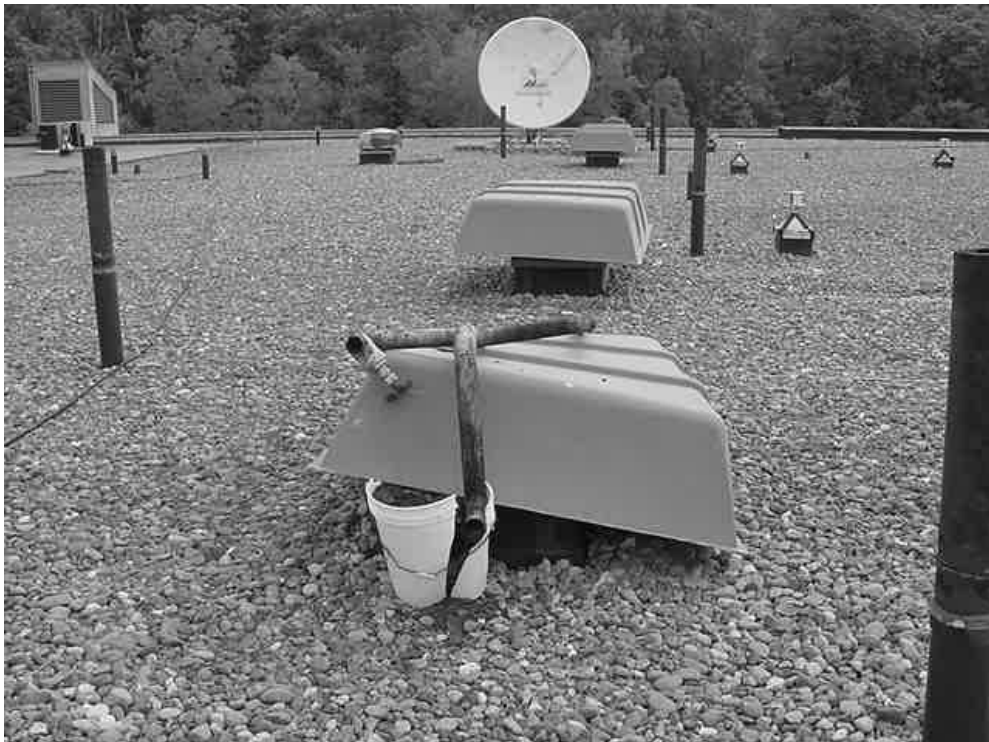
Picture 4

**Air Intakes for Univents in Interior Classrooms
Note Bucket Stationed beneath Broken Intake Vent to Allow Airflow**

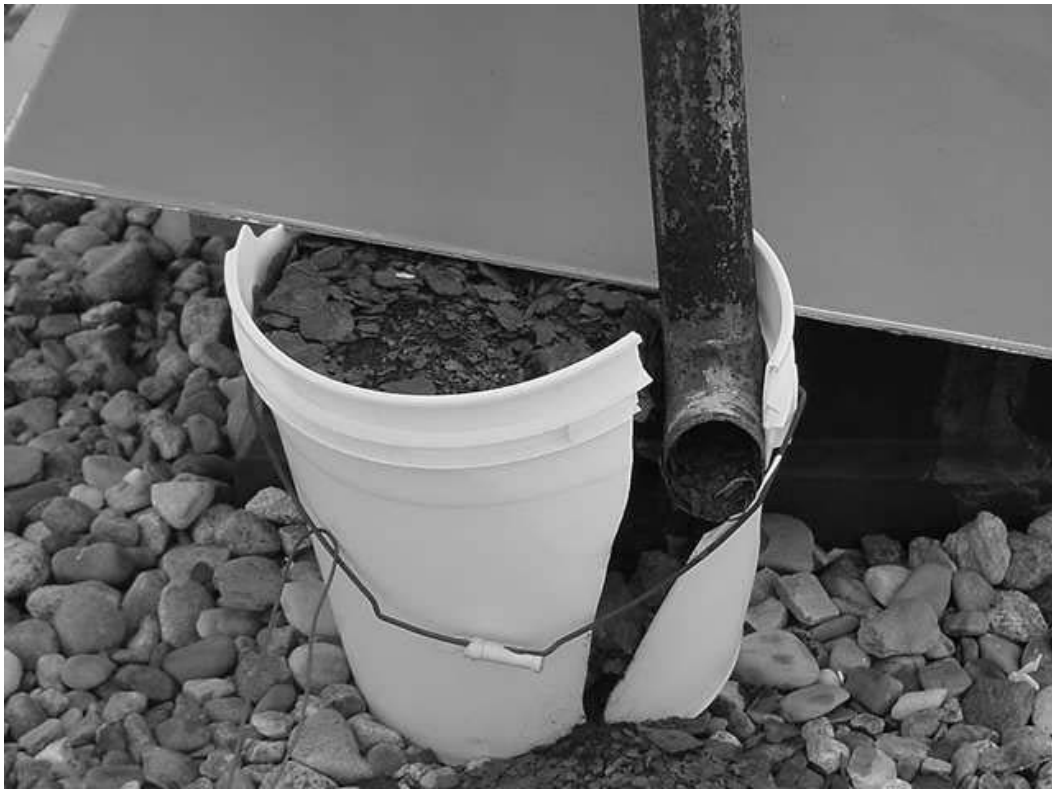
Picture 5

Close Up Of Bucket Filled with Rust Chips in Picture 4

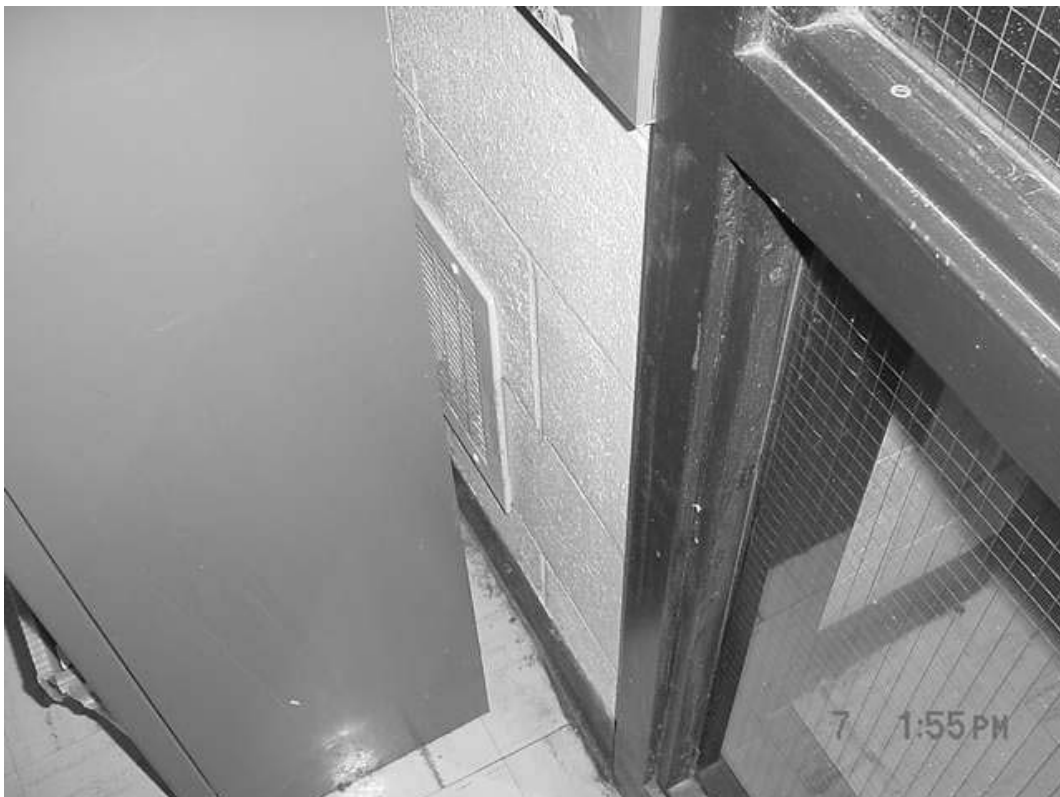
Picture 6

Wall Mounted Exhaust Vent Obstructed by Filing Cabinet

5. Inspect rooftop exhaust motors and belts for proper function, repair and replace as necessary.
6. Remove all blockages from univents, air diffusers and exhaust vents to facilitate airflow.

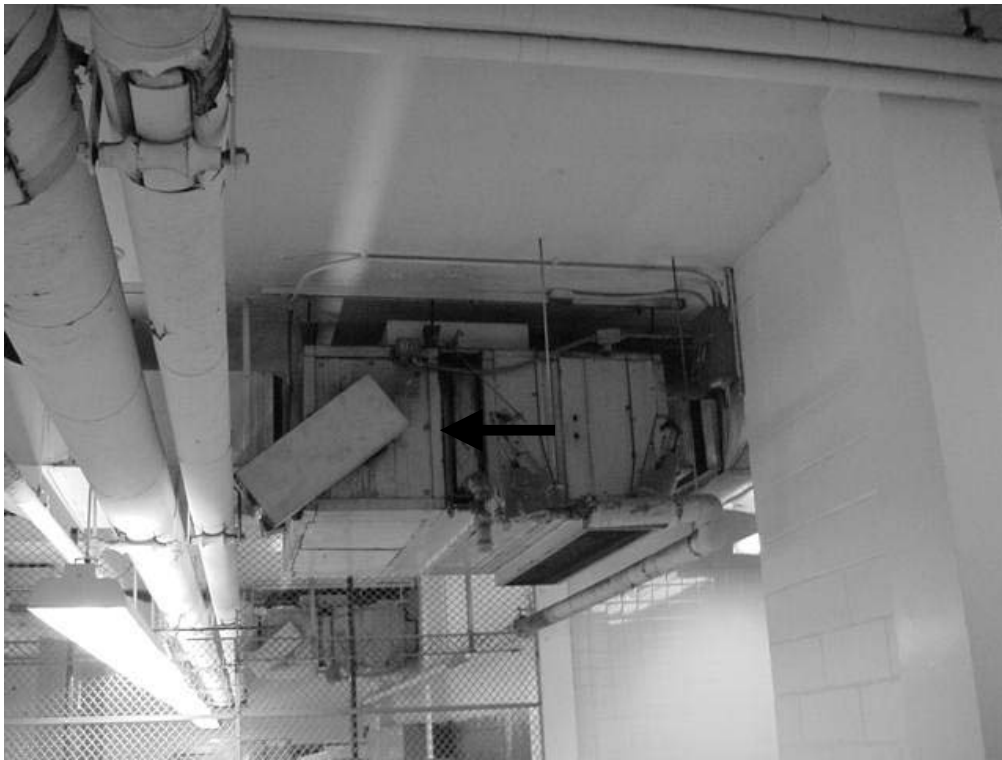
Picture 7

Mechanical Ventilation in offices and common areas (auditorium, library, gymnasium/locker rooms, etc.) is provided by air handling units (AHUs) (see Picture 7). Air is distributed by ducted, ceiling vents located throughout the building. Several air diffusers were sealed with plastic sheeting and/or cardboard (see Pictures 8 & 9). Alterations of the system such as these can interfere with proper airflow and balancing, resulting in the creation of uneven heating/cooling conditions in other areas. Exhaust ventilation is provided by wall or ceiling-mounted grates that return air back to the AHUs via ductwork.

Ceiling Mounted AHU in Locker Room, Note Panel for Filter Bank Not Secured

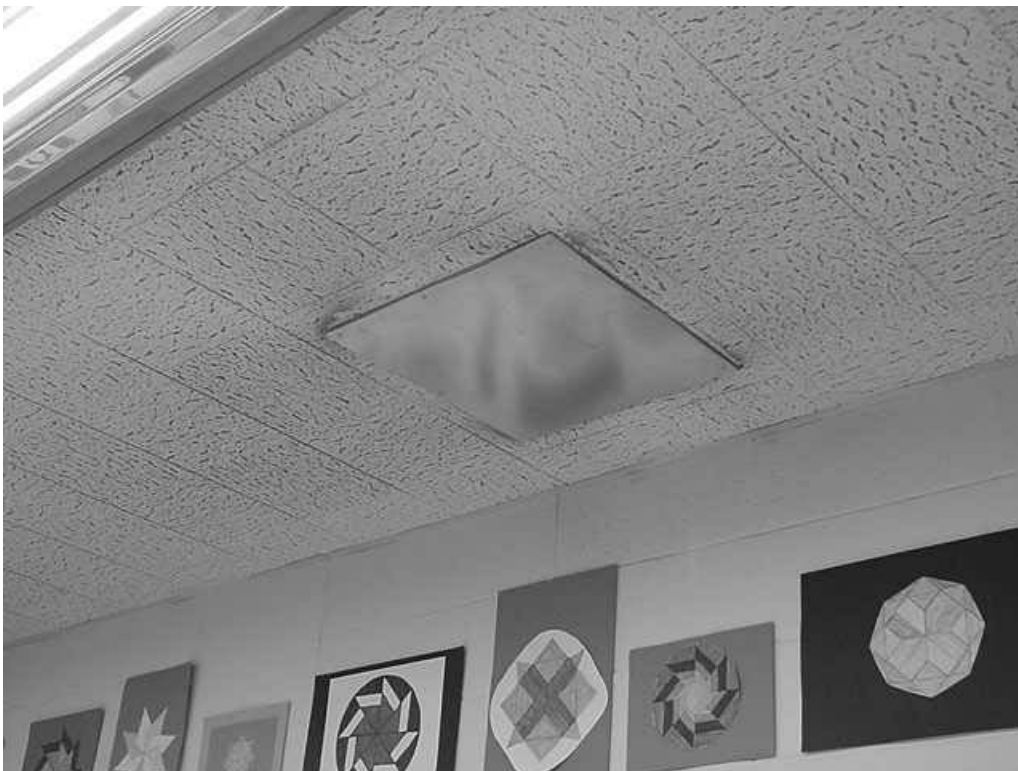
Picture 8

Air Diffuser Blocked by Sheet Metal

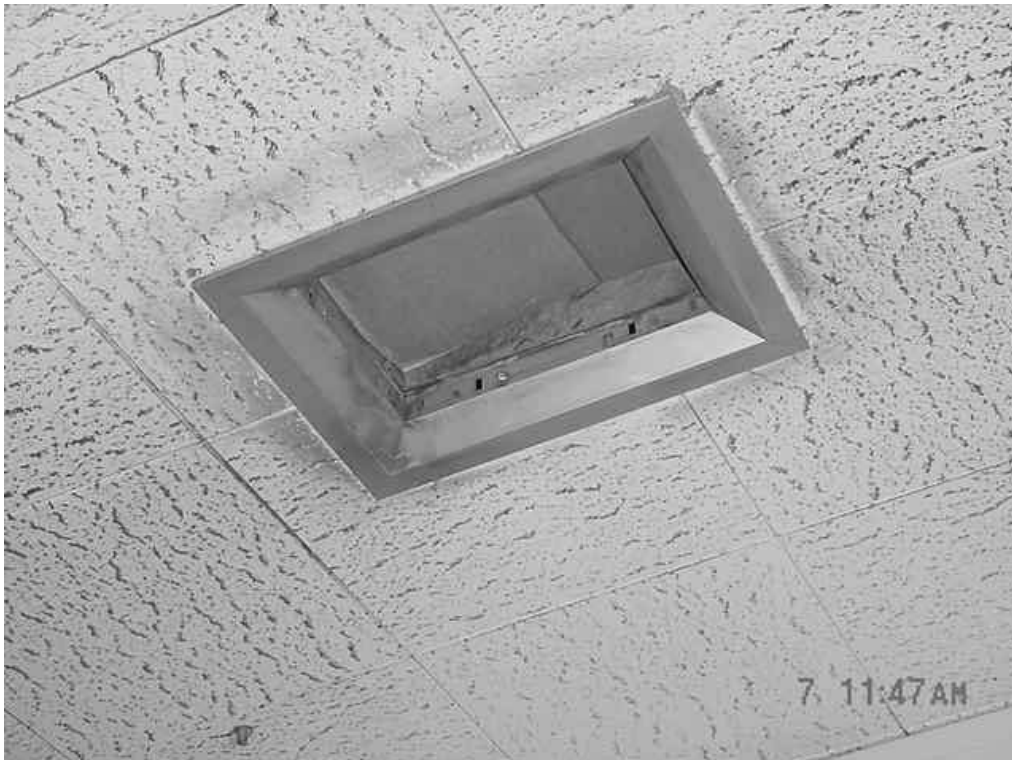
Picture 9

Air Diffuser Blocked with Cardboard

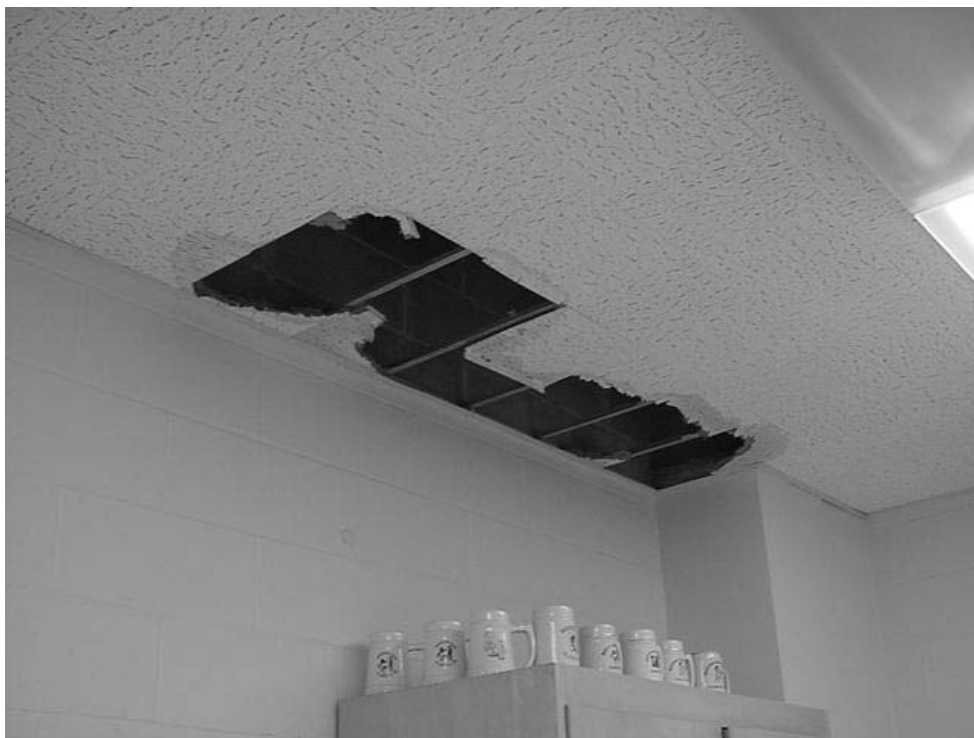
Picture 10

Water Damaged/Missing Ceiling Tiles

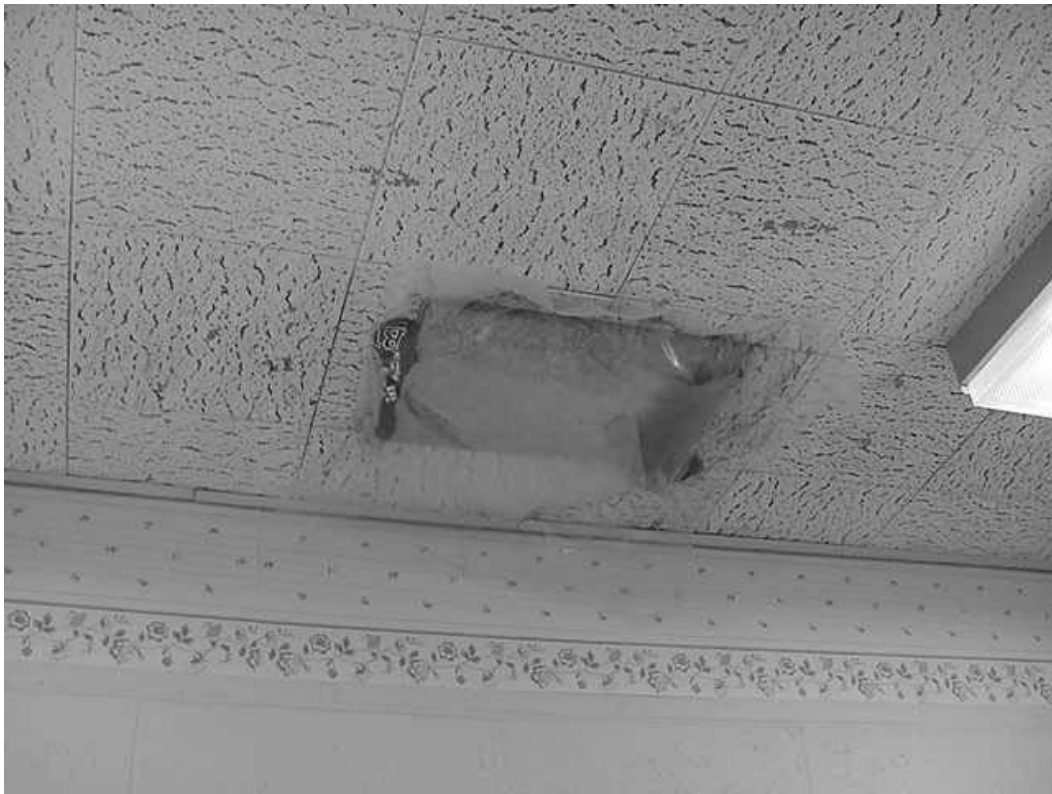
Picture 11

Water Damaged Ceiling Tiles with Possible Mold Growth (Sealed with Plastic)

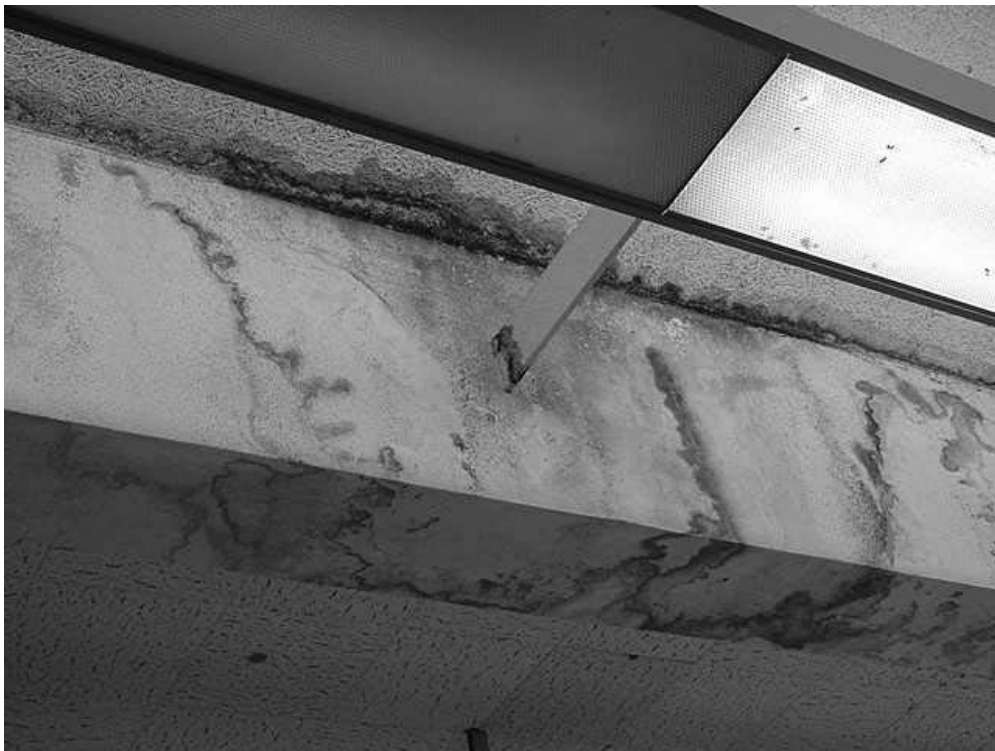
Picture 12

The building has had a history of water damage, most notably the art wing, library, the science wing and the AV workroom off the library. A number of classrooms and common areas throughout the building have water-damaged ceiling tiles and other building materials, which indicate leaks from either the roof or plumbing system (see Pictures 10-12). Possible mold growth was identified on a support beam near the ceiling in second floor art rooms (see Pictures 12 & 13).

Water Damaged Support Beam and Ceiling Tiles in Art Room (Possible Mold Growth)

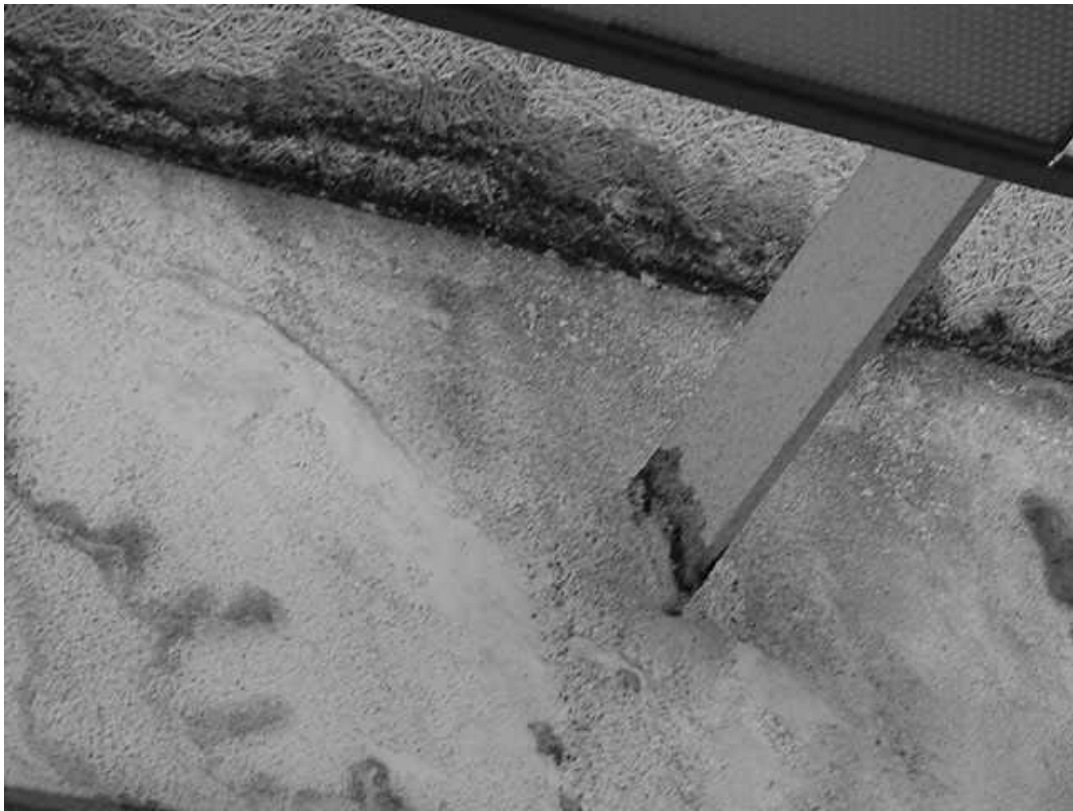
Picture 13

Close-Up of Water Damaged Area in Previous Picture

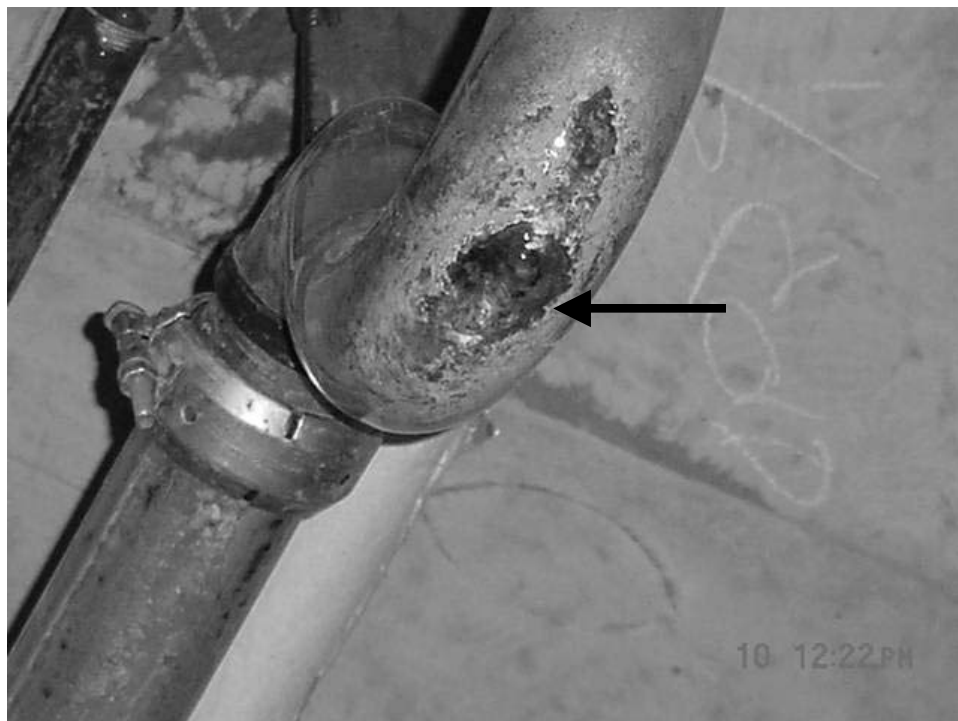
The area with the most substantial water damage appeared to be in the science wing as a result of piping/valves of science classrooms. An active leak was observed in this area with buckets stationed beneath to collect water (see Picture 14 & 15). The leak was traced to a chemical bench in room B-314 from plumbing that had penetrated through a space in the floor around a drain, resulting in water damage to the ceiling system. Other areas had significant water damage. Room B III has substantial water damage to desk table tops. A mailbox is used to collect water from leaks to prevent further damage (see Picture 16). Increasing the difficulty of replacing ceiling tiles is the

**Leaking Plumbing Valve in Science Wing
Note Water Droplets**

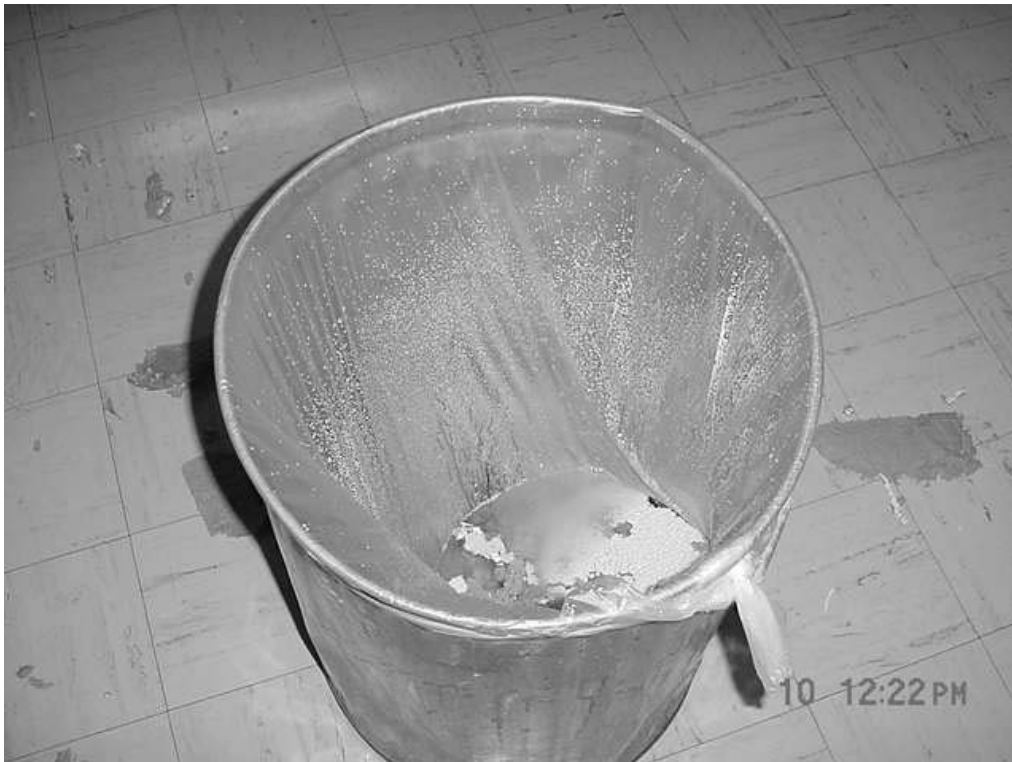
Picture 15

Bucket With Standing Water Stationed below Leak in Previous Picture

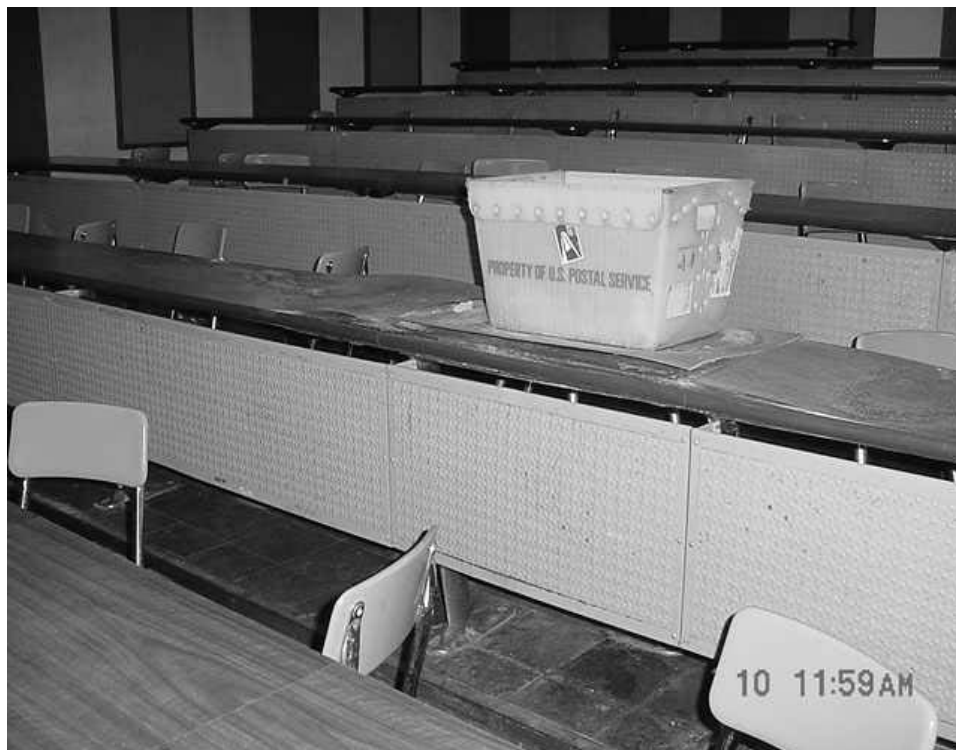
Picture 16

A Mail Box Is Used To Collect Water From Leaks To Prevent Further Damage To Desks In BIII

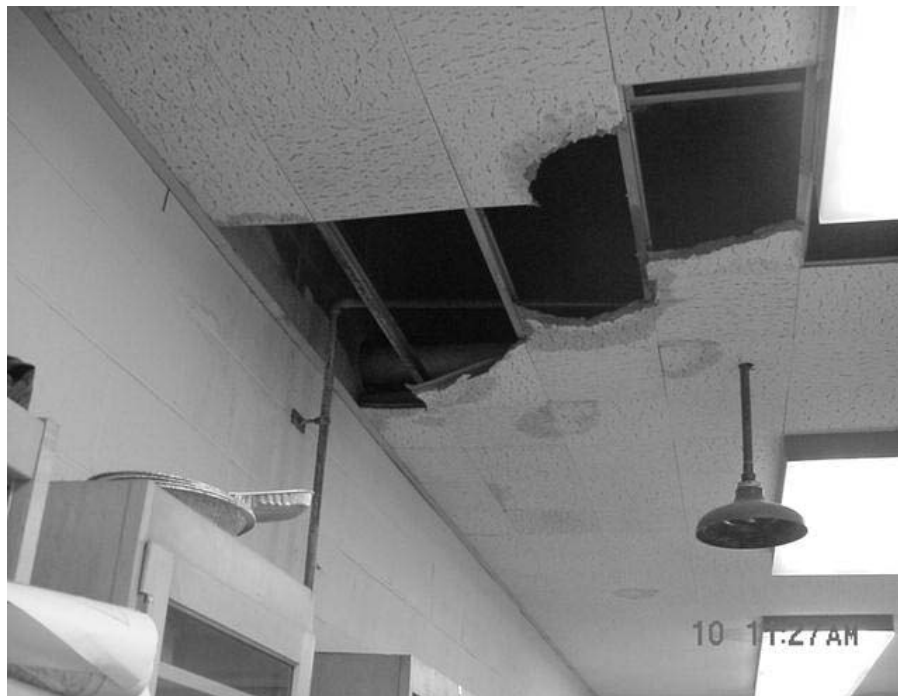
Picture 17

suspended ceiling design. The system consists of a suspended ceiling of interlocking tiles, which requires the removal of a number of tiles (see Picture 17). This design renders replacement of water damaged tile difficult. Water-damaged ceiling tiles and other porous building materials can provide a source of microbial growth and should be replaced after a water leak is discovered. As an example, chronically moistened ceiling tiles in the print shop supply room have resulted in mold contamination (see Picture 18).

The Ceiling System Consists Of Interlocking Tiles

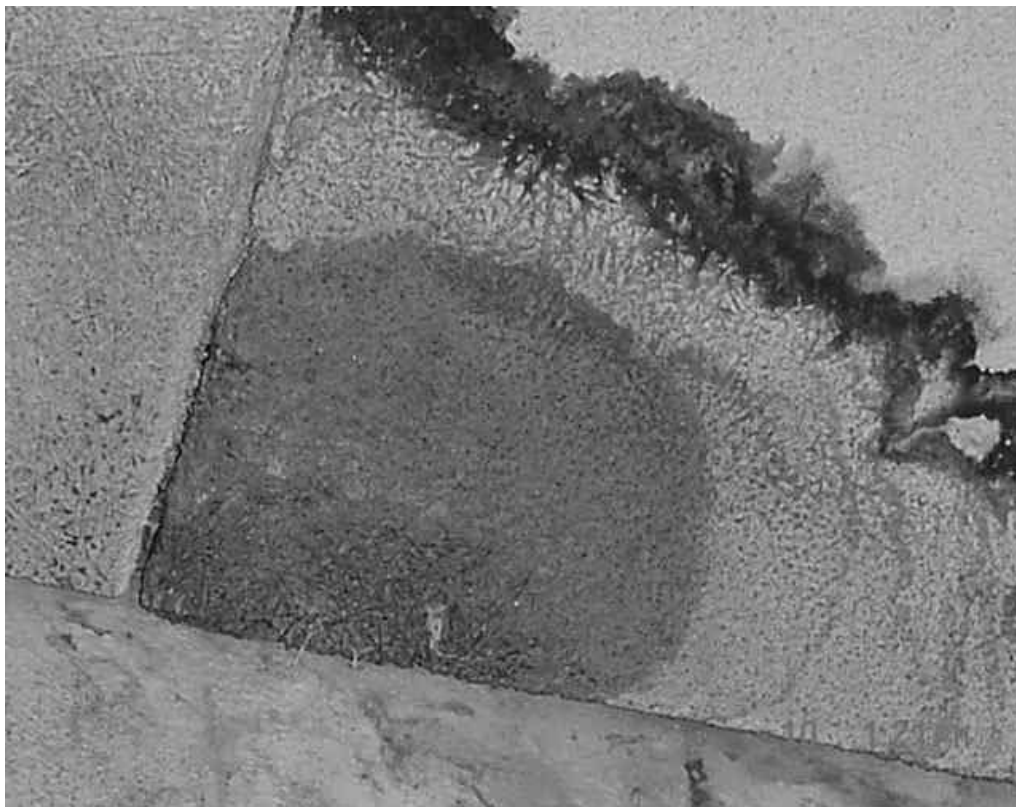
Picture 18

Mold Contamination of Ceiling Tiles in Print Shop Storeroom

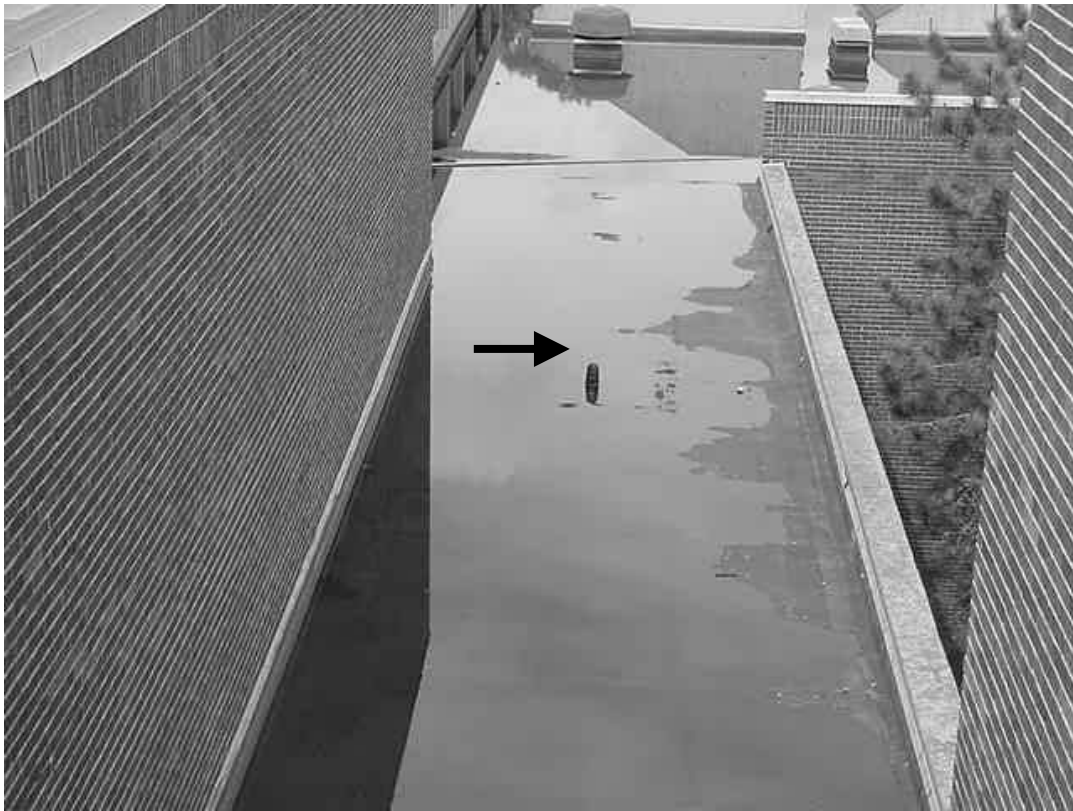
Picture 19

Pooling water was observed in a number of areas on the roof (see Pictures 19 & 20). The art rooms are located in a section of the building, which has a steep saw-tooth style roof (see Picture 21). The drainage system on roofs of this design are prone to blockage by debris (e.g., leaves, pine needles) or snow and/or ice dams during winter months, which cause water to accumulate in the trough sections of the roof. Also, roof drain strainers were either missing and/or clogged with debris (see Pictures 22 & 23). The freezing and thawing of water during winter months can lead to roof leaks and subsequent water penetration into the interior of the building. Pooling water can also become stagnant, which can lead to mold and bacterial growth that can be introduced into the building by rooftop fresh air intakes (see Picture 24). In addition, stagnant pools of water can serve as a breeding ground for mosquitoes.

Pooling Water on Roof Note Drain Indicated by Arrow

3. Clean roof drain catches of debris to enhance rainwater drainage. Replace all missing/damaged drain catches to prevent drain clogs. Examine each roof drain for clogs and remove where found. Consider instituting roof inspections on a regular basis to examine catch basins for blockage.

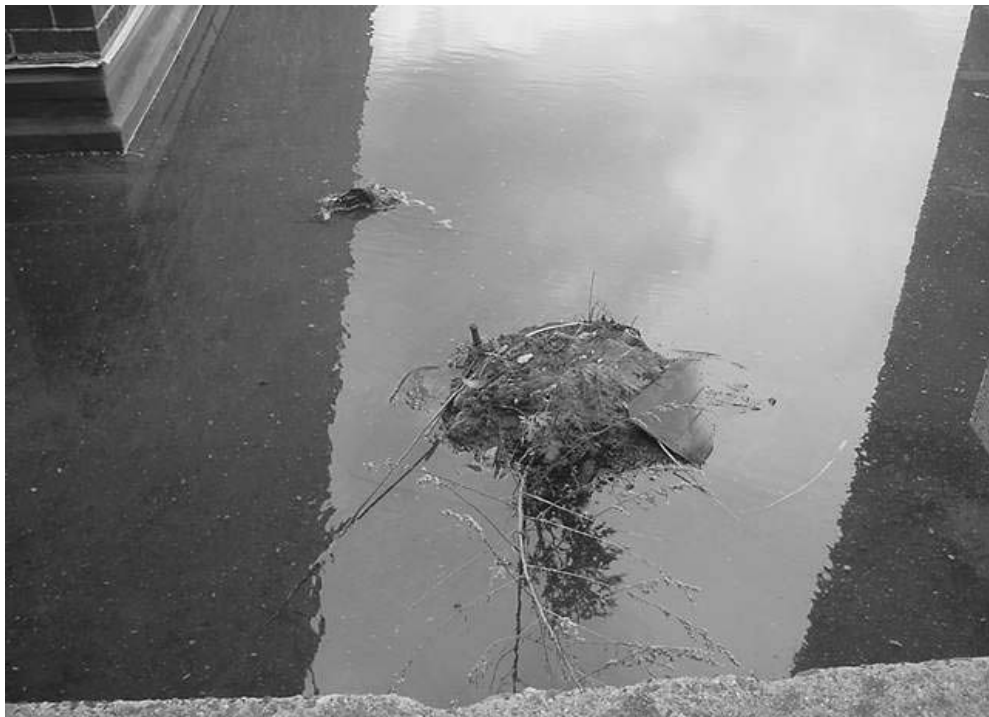
Picture 20

Pooling Water on Roof Note Plant Growth and Debris

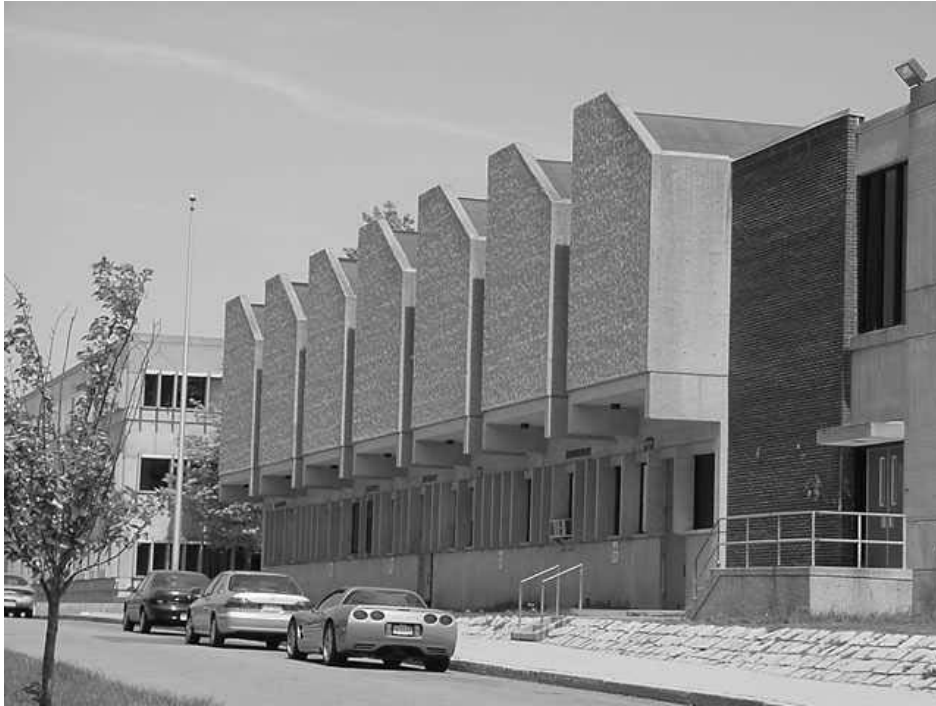
Picture 21

Saw-Toothed Roof over Art Wing

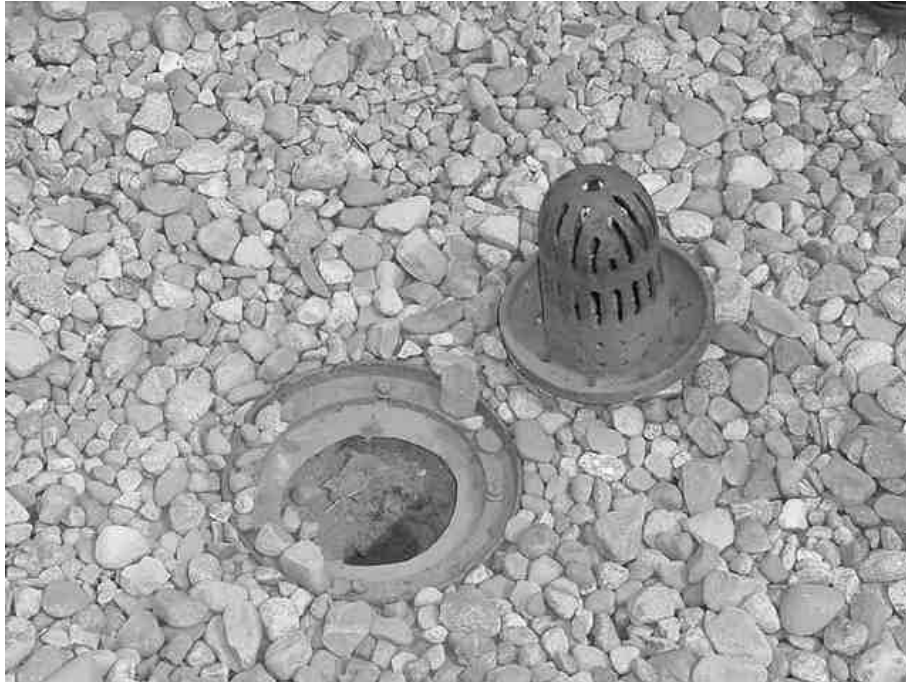
Picture 22

Roof Drain, Note Strainer Not Secured

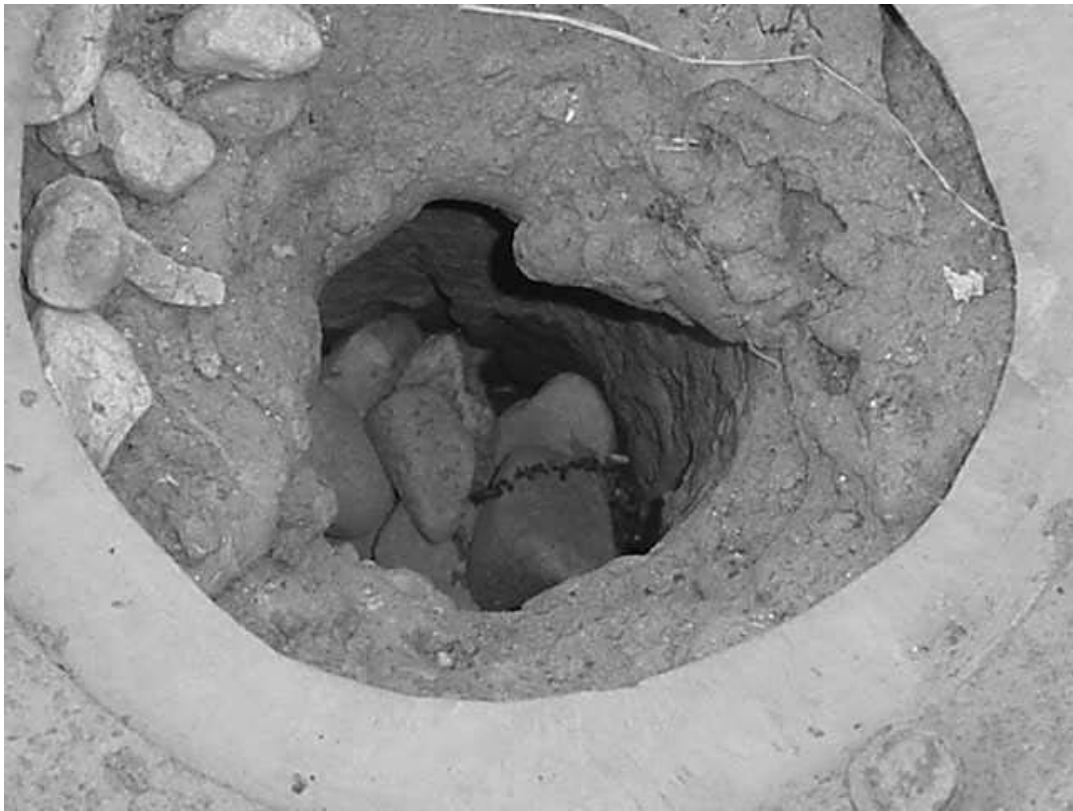
Picture 23

Close-Up Of Drain in Previous Picture, Note Drain Clogged With Stones

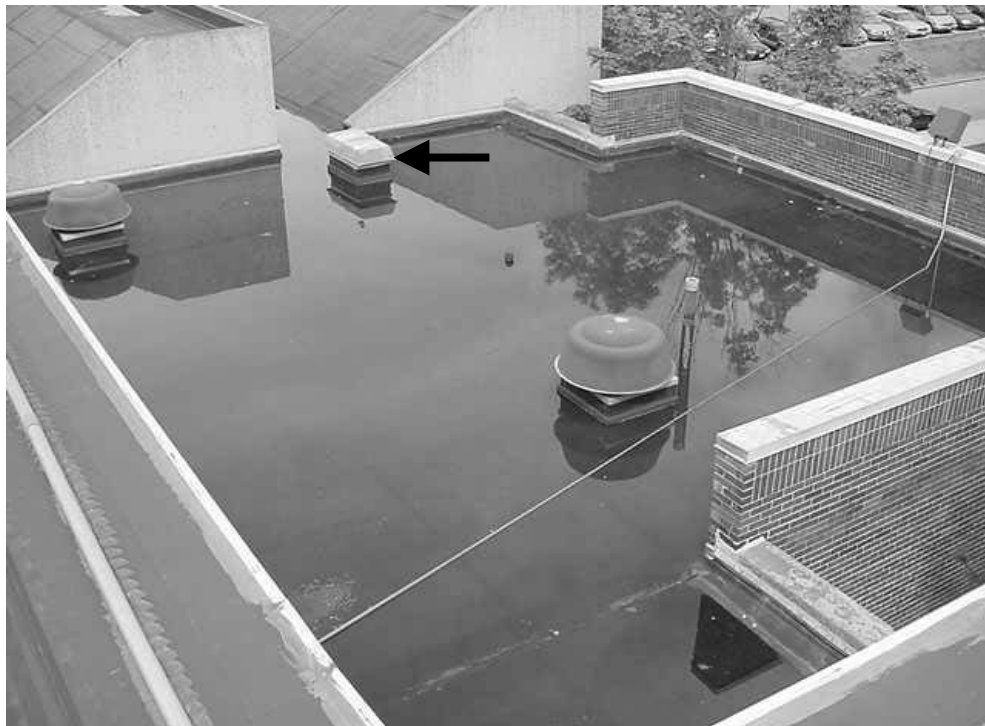
Picture 24

Pooling Water on Roof, Note Fresh Air Intake near Saw-Toothed Roof (Art Wing) In Background

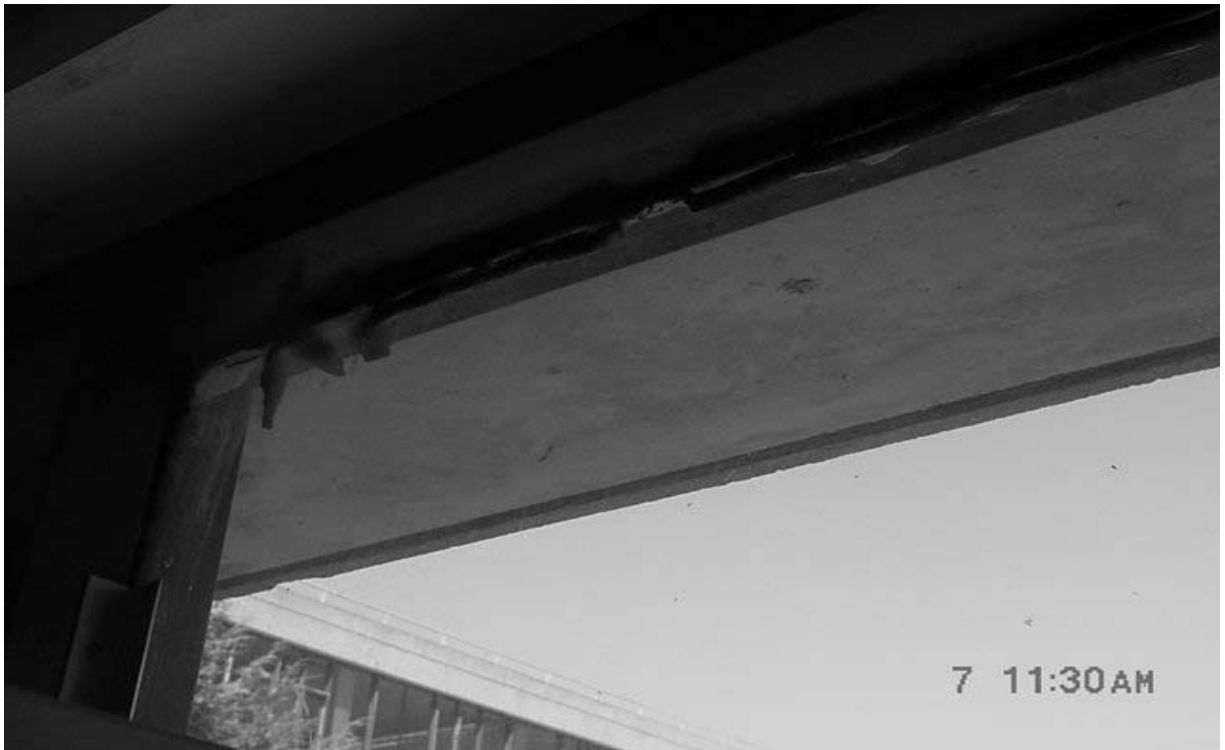
Picture 25

Caulking around windows was crumbling/damaged throughout the building indicating that the water seal is no longer intact (see Picture 25). Water penetration through window frames can lead to mold growth under certain conditions. Replacement of caulking and repairs of window leaks are necessary to prevent water penetration.

Failing Caulking around Windows (Top)

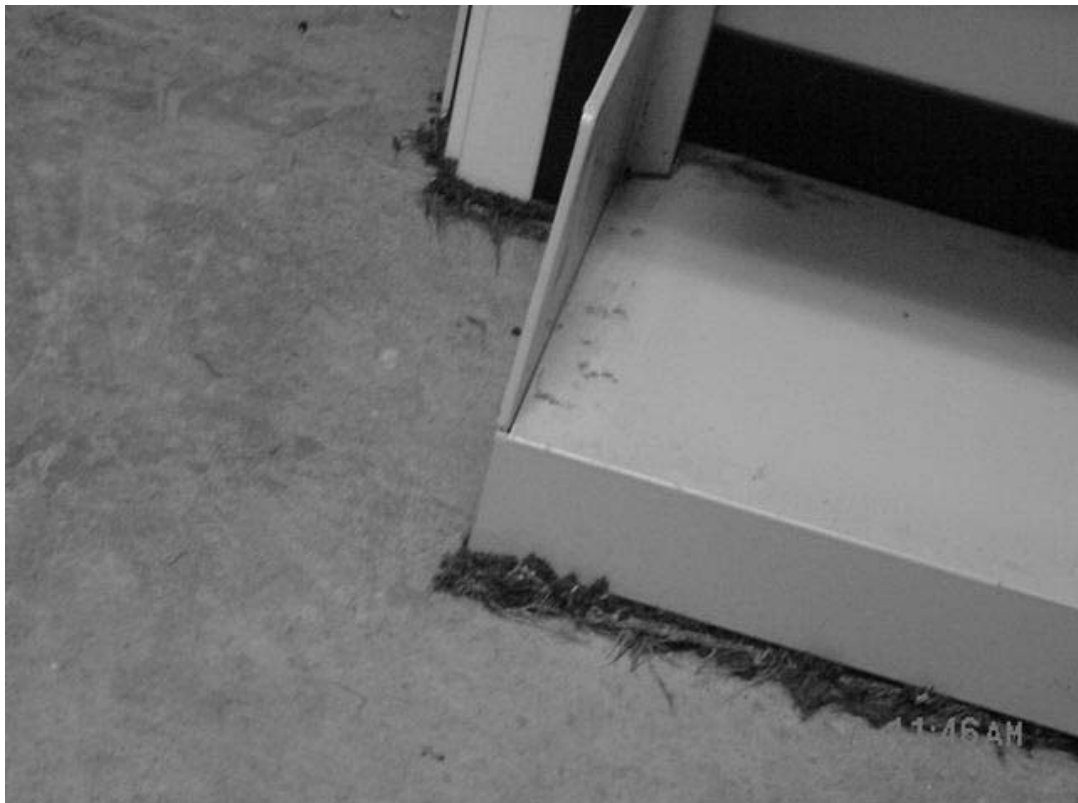
Picture 26

Musty odors were detected in the office space in the library. The origin of the odors was traced to wet carpeting that had been damaged prior to the BEHA assessment. Water damaged carpeting was reported to have been removed, however remnants of carpeting were observed along the perimeter of the media office beneath furniture presumable too heavy to relocate in order to remove carpeting (see Picture 26). In addition, BEHA staff identified wet carpeting emitting musty odors in a closet across from the video room, in which carpet removal was overlooked (see Picture 27). The American Conference of Governmental Industrial Hygienists (ACGIH) recommends that carpeting be dried with fans and heating within 24 hours of becoming wet (ACGIH, 1989). If carpets are not dried within this time frame, mold growth may occur. Water-damaged carpeting cannot be adequately cleaned to remove mold growth.

Remnants of Wet Water Damaged Carpeting beneath Furniture in Media Office

13. Examine water-damaged carpeting for mold growth. Discard carpet if moldy. Ensure all carpet remnants and backing materials are removed. Disinfect areas beneath and around carpeting with an appropriate antimicrobial.
